Gardner Area Flame Length Output

County Road 580

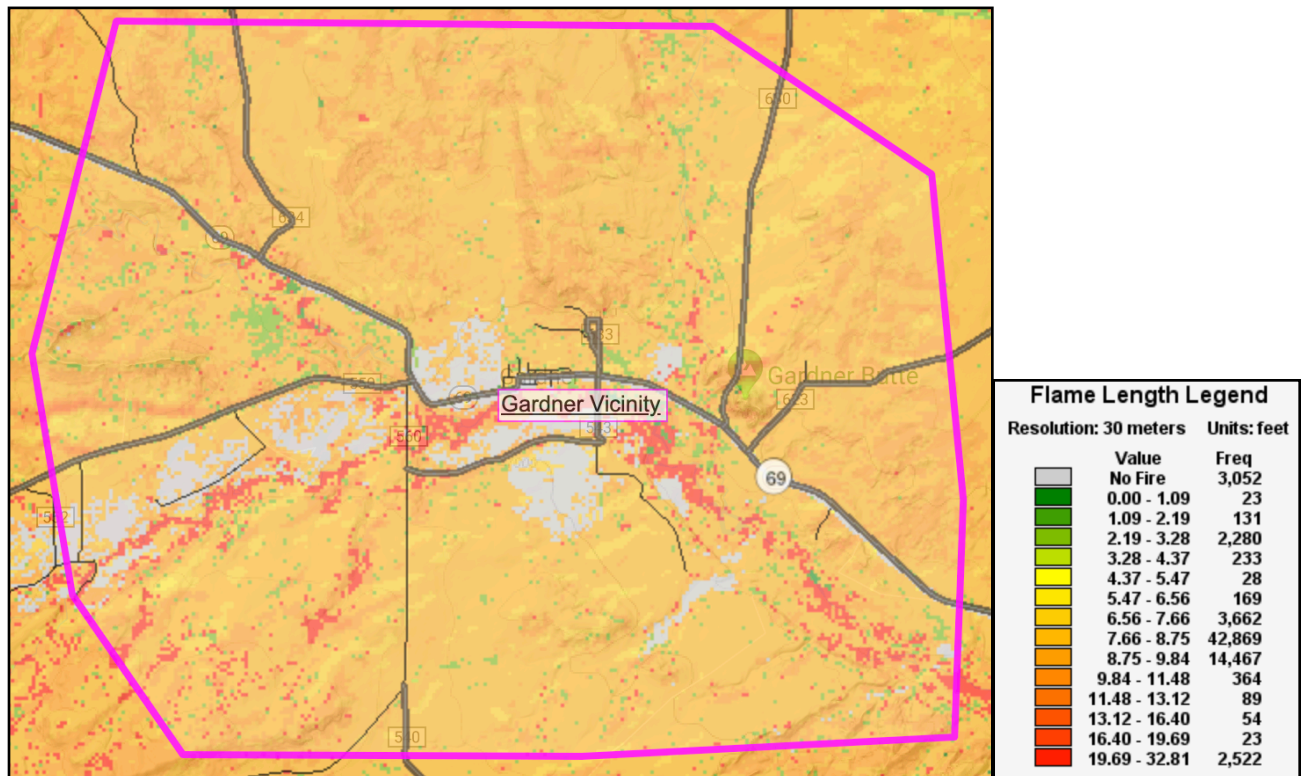
Flame Length output: The scattered green pixels show areas that are of very low flame lengths but are of such a small consequence that they will most likely not alter fire behavior much. Most of the analysis area is made up of flame lengths that are in the 5.5 to 10 foot range. This demonstrates that most fires under these dry conditions will need to have an engine included in the response, since flames over 4 feet are not easily handled with individuals or hand crews. The rest of the analysis area has oranges and reds along the creek bottom and in stringers of shrub and shrub/grass areas. These areas will create flames in the 10 foot and greater classes. Since the areas are not large and contiguous they will display large flames as pulses but will quickly transition to some of the shorter flames. It will still be of concern but not something that would trigger use of aerial resources unless they are on scene and can be used without getting retardant in the stream courses. The grey areas that are showing as no fire are either bare soils or agricultural areas with grazing or haying operations.

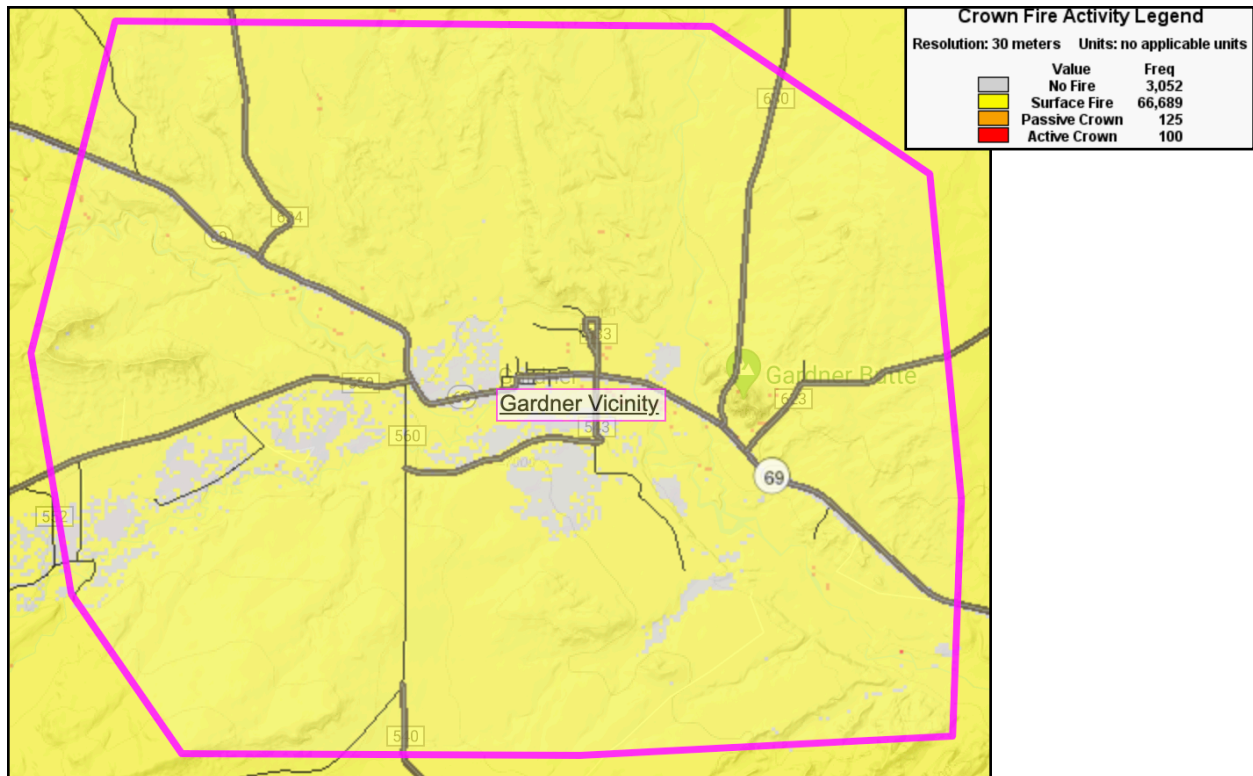
Gardner Area Crown Fire Activity Output

Crown Fire Activity output: Crown fire activity within Gardner area is pretty consistent surface fire throughout. There are some large areas to the the west and south of the town that show no fire, these are either bare ground or areas of such low fuel that they cannot consistently carry fire. There are very few pixels with passive crown fire scattered throughout the analysis area, these are most likely isolated areas of thicker brush or even scattered piñon and juniper trees.

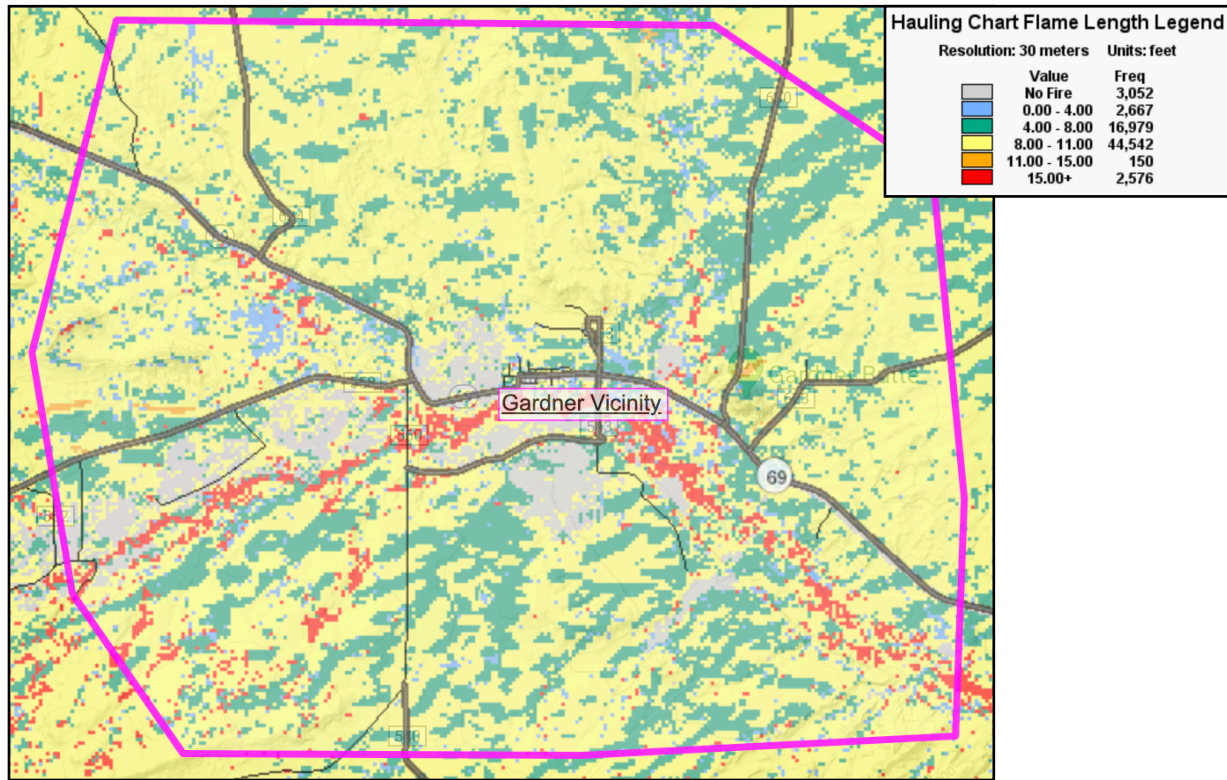
Gardner Area Hauling Chart Output

Hauling Chart output: The hauling chart output shows that the greater majority of the analysis area is in the 8 to 11 foot flame length range as well as a significant portion in the 4 to 8 foot range, this would require use of heavy equipment most of the time. There are small, isolated areas of blue color that is in the 0 to 4 foot flame length range, these are areas that could be handled by a hand crew with out support from an engine or other heavy equipment. The orange and reds are 11 foot and higher flame lengths, these appear to be mostly in the riparian areas along the creek bottoms. There are also a few larger areas north of Gardner Butte that are most likely scattered piñon and juniper stands that might torch.

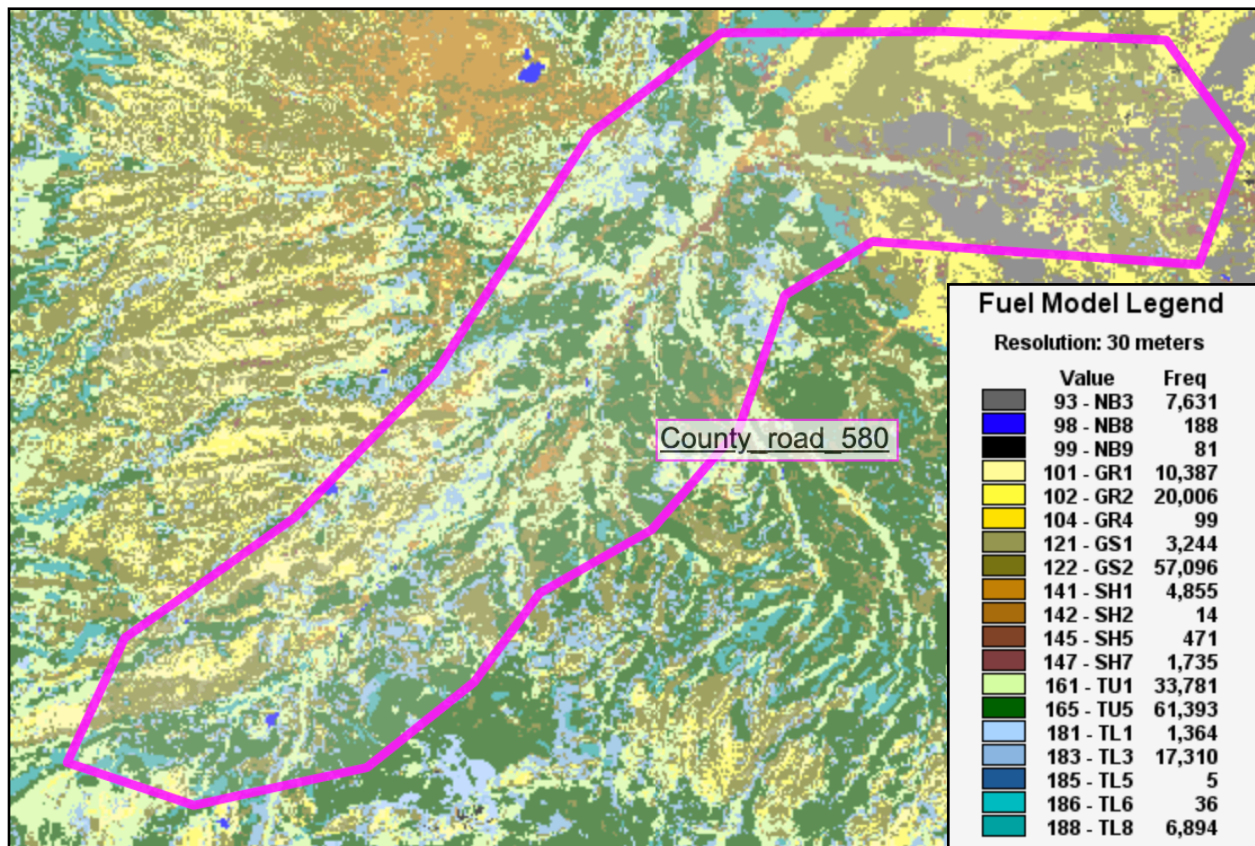
County Road 580 Fuel Model Output

The fuel models for the County Road 580 area are split into three seemingly distinct areas. The northeast is ranching lands with scattered homes and mostly in the grass and grass/shrub models, as well as a few areas of non-burnable models. The non-burnable areas are alfalfa and grass hay fields that are irrigated and actively cut during the summer season. The large expanses of grass/shrub fuel models are dry

uplands with a mixture of four-wing salt bush, black greasewood, rubber rabbit brush with short grasses (natives and cheat grass) and weeds mixed in between.

The middle section has a mixture of timber understory and timber litter models. Species present in the timber understory on the south facing slopes are piñon/juniper and scattered limber pines with sparse grass and shrubs. The north aspect slopes are some piñon/juniper with Douglas fir and ponderosa pine. The timber litter

component is mostly ponderosa pine with a good loading of needle cast, dead limbs and decaying shrubs.

The creek bottoms along the riparian areas have scattered pieces of pure shrub models that are made up of willows, service berry, sumac chokecherry, Russian olive and cottonwoods. There is well developed grass and herbaceous understory that during dry seasons will carry very well and even ladder up into the Russian olive and cottonwoods.

The far southwest area of the analysis area has both timber models on the north aspects and grass and grass/shrub models on the south aspects. As the elevation goes up towards the end of the road, the timber understory models along the valley bottom pick up more aspen, blue spruce and white fir in addition to the cottonwoods and willows. There is a significant loading of dead and down material from aspens and cottonwoods and dying shrubs. The white fir is trying to take over some of the aspen stands and are only about 7 to 15 feet tall, making a significant fuel load of understory ladder fuels.

Near the end of the road to the southwest, south of the creek, the timber litter fuel models are primarily large aspen stands that are remnants from a stand replacement event such as fire or beetle kills, possibly over 100 years ago. There are stringers of limber pine, Douglas fir and white fir mixed in with open short grass meadows.

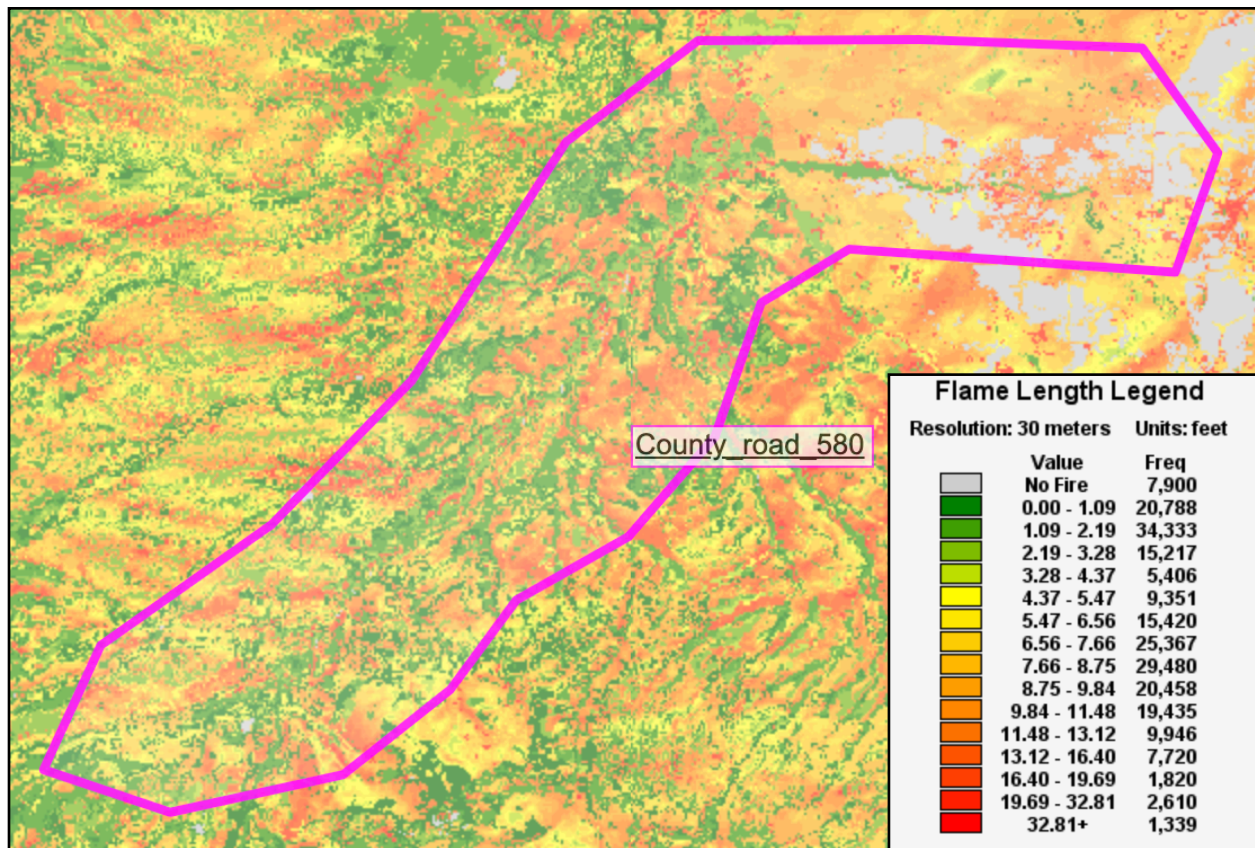
County Road 580 Flame Length Output

Flame Length output: The northeast portion of the analysis area that is mostly ranching properties shows flame lengths that indicative of the grass and grass/shrub fuel models present. Flame lengths are mostly in the in the yellow, orange and spots of red meaning that they are mostly above 5 foot in length with concentrations of fuels that could torch with longer flames. Right along the creek bottom there is a trailing piece of green or very short flames. These are mixed in with the no fire or grey color.

The central portion of the analysis area has real mixture of flame lengths, showing that depending on whether fire is burning in a timber understory that is made up of grasses and shrubs or a dense short needle mat, fire will be less active and mostly on the surface. The areas of orange to reds show that there is a more well developed understory of small trees and shrubs that can carry fire with much longer flame lengths. Some of the more dominate red areas along the creek bottom is the shrub fuel models that are much heavier in loading and more prone to ladder into the adjoining trees.

The southwest portion of the analysis area seems to be more in the middle of the flame length spectrum with the majority of the area in the yellows and oranges or 4 to 8 foot flame lengths. This is primarily due to the gain in elevation and a more diverse landscape that has small, tight canyons funneling down into the main channel along the creek bottom.

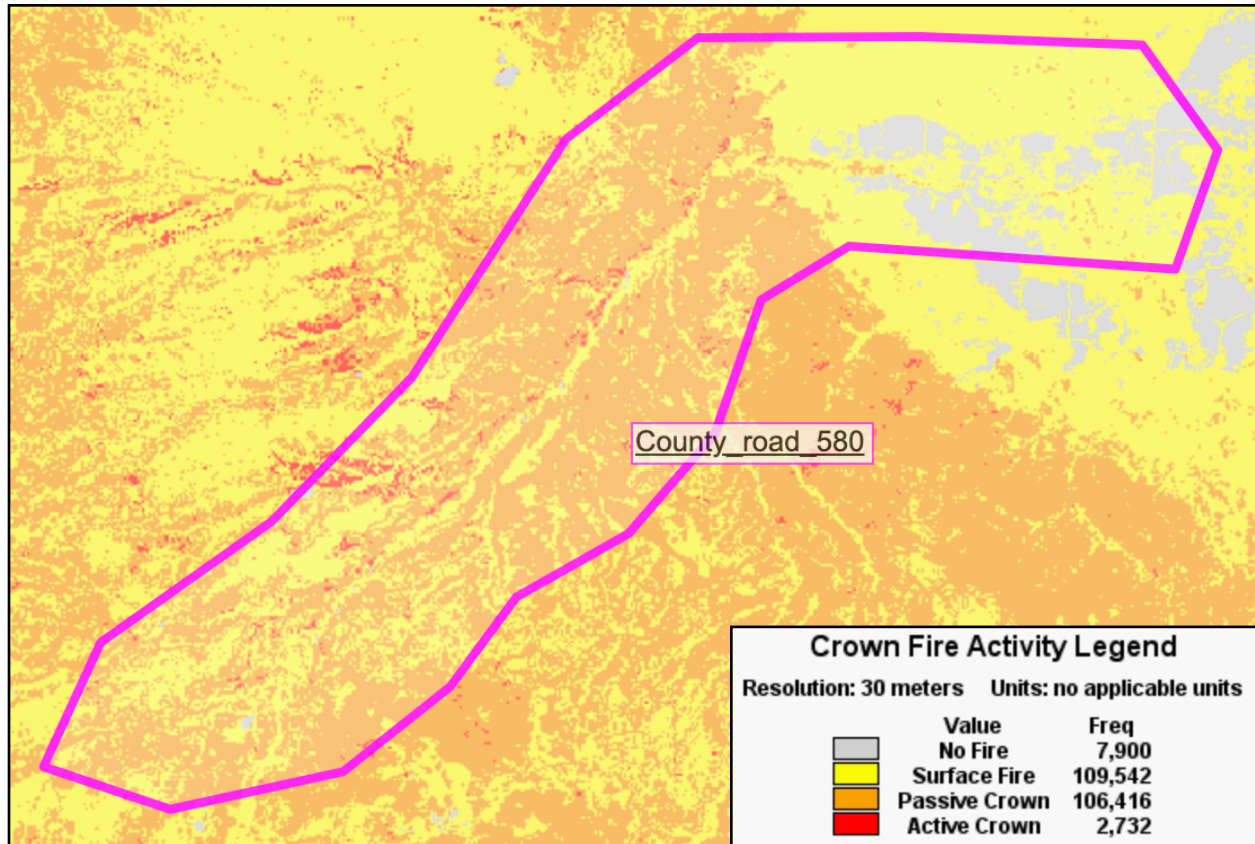
County Road 580 Crown Fire Activity Output

Crown Fire Activity output: Crown fire activity along County Road 580 is in two distinct zones. The northeastern quarter is dominated by the surface fire category with only a few passive crown fire areas and the areas that won't support fire, primarily due to it being irrigated agricultural fields. The rest of the analysis area is mostly passive crown fire with a mixture of surface fire and spots of active crown fire. The active crown fire along the northwest analysis boundary line is from stringers of shrubs.

The higher elevation area in the far southwest of the analysis area shows a mixture of passive and surface fire. This can be a good thing, since even though passive crown fire has trees independently torching, it doesn't always mean that there will be

sustained torching. Fire moving through this part of the landscape, depending on the time of day and weather conditions, might just be surface fire or spots of very isolated torching since it is such discontinuous and non-homogenous fuel types. The middle portion of the analysis area is more problematic in that there is so much more passive crown fire and very little of the surface fire. This could transition to what could act like more active crown fire much easier depending on time of day and minor shifts in wind or humidity.

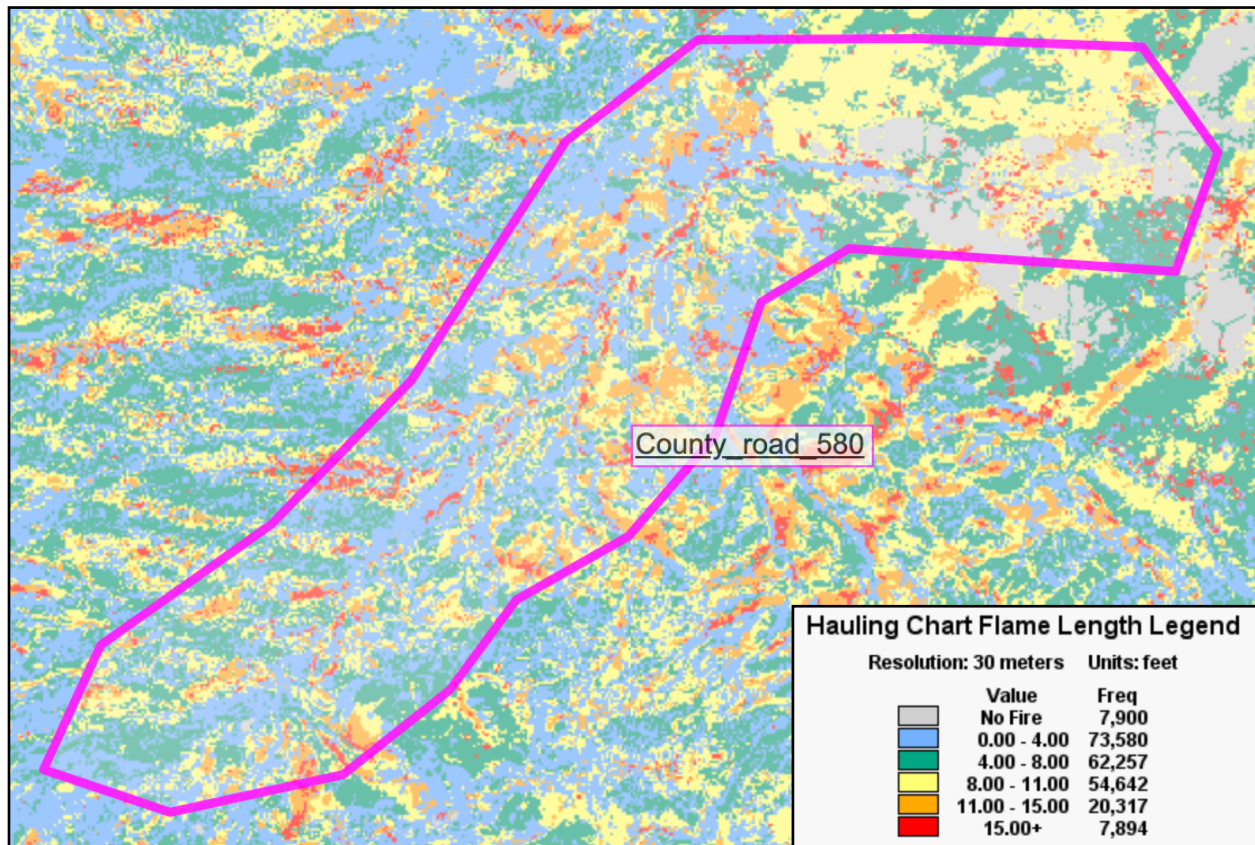
County Road 580 Hauling Chart Output

Hauling Chart output: The hauling chart output shows that about two-thirds of the analysis area is in the 0 to 8 foot flame length range as well as a scattered portions in the 8 to 11 foot range, this would require the use of heavy equipment most of the time. Given that the canyon is steep sided in places and very rocky, dozers would have difficult time getting wirelines established. The orange and reds are 11 foot and higher flame lengths, these appear to be mostly in the stringers of timber on north aspects or areas along the creek bottoms with shrubs and small trees underneath the over-story.
